MIAMI-DADE TEST REPORT

TAS 201, TAS 202, AND TAS 203 TESTING ON ALUMINUM CASEMENT WINDOW

211217011SHF-001

Series/Model: ROPO100CW

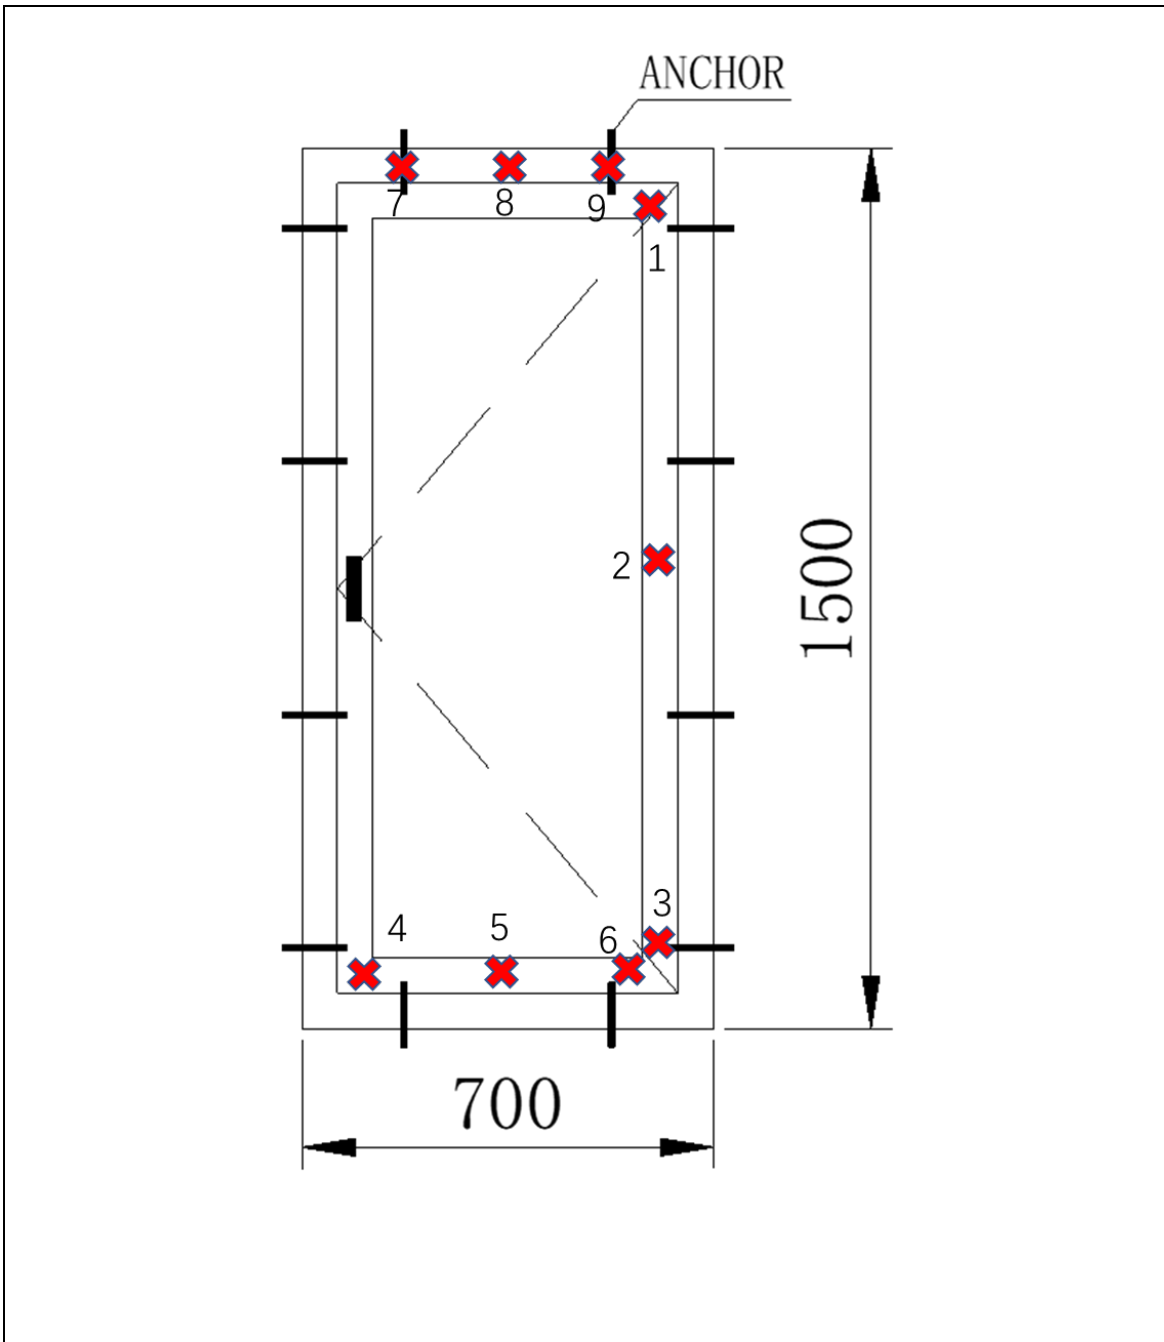
Sketch No. 1
TAS 202 Indicator Locations of specimen #1

Note 4: See Sketch No. 1 for indicator locations. Deflection/permanent set reported is the overall deflection between three points (longest unsupported span) which accounts for support movement.

LOAD (psf)	INDICATOR LOCATION	DEFLECTION (in.)		PERMANENT SET (in.)	
		MEASURED	ALLOWED	MEASURED	ALLOWED
+45.0 50% of Test Pressure	2	0.01	NA	<0.01	NA
	5	<0.01	NA	<0.01	NA
	8	<0.01	NA	<0.01	NA
+60.0 Design Pressure	2	0.02	0.26	<0.01	NA
	5	<0.01	0.10	<0.01	NA
	8	<0.01	0.09	<0.01	NA

LOAD (psf)	INDICATOR LOCATION	DEFLECTION (in.)		PERMANENT SET (in.)	
		MEASURED	ALLOWED	MEASURED	ALLOWED
-45.0 50% of Test Pressure	2	0.05	NA	<0.01	NA
	5	<0.01	NA	<0.01	NA
	8	<0.01	NA	<0.01	NA
-60.0 Design Pressure	2	0.06	0.26	<0.01	NA
	5	<0.01	0.10	<0.01	NA
	8	<0.01	0.09	<0.01	NA

LOAD (psf)	INDICATOR LOCATION	DEFLECTION (in.)		PERMANENT SET (in.)	
		MEASURED	ALLOWED	MEASURED	ALLOWED
+90.0 Test Pressure	2	0.04	NA	0.01	0.09
	5	<0.01	NA	<0.01	0.04
	8	<0.01	NA	<0.01	0.03
-90.0 Test Pressure	2	0.08	NA	<0.01	0.09
	5	<0.01	NA	<0.01	0.04
	8	<0.01	NA	<0.01	0.03

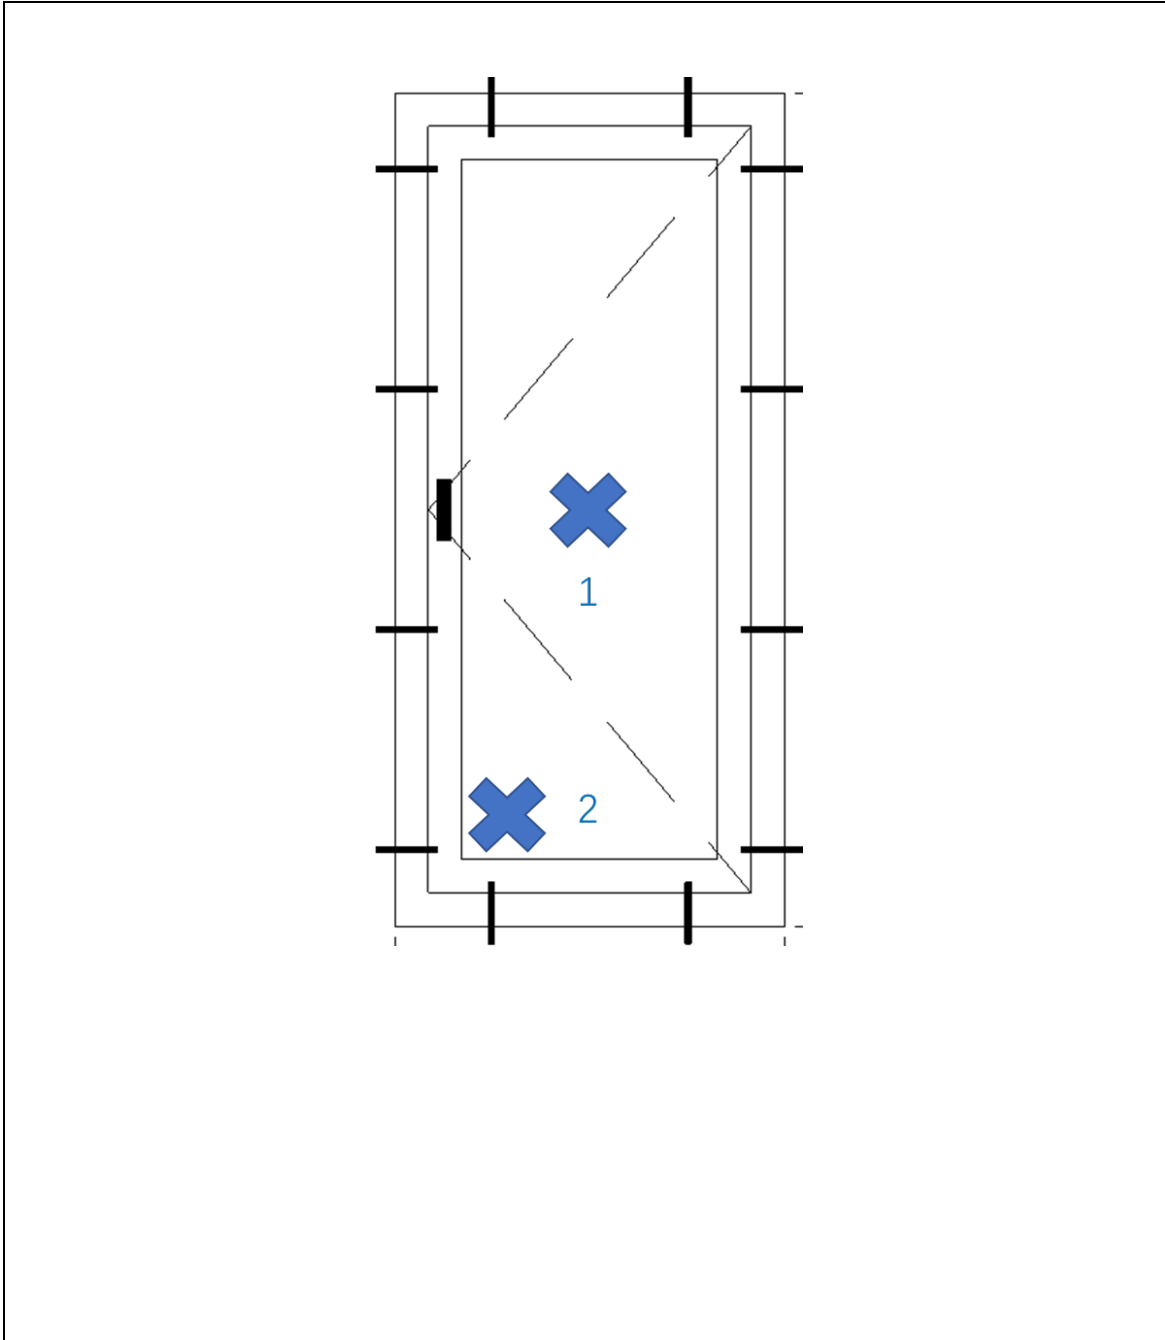
Sketch No. 2
TAS 201 Impact Locations of specimen #1

Note 5: See Sketch #2, #3 and #4 for impact locations.

IMPACT #	MISSILE WEIGHT (lbs.)	MISSILE LENGTH (in.)	MISSILE VELOCITY (ft./sec.)
1	9.3	94	49.5
2			49.5

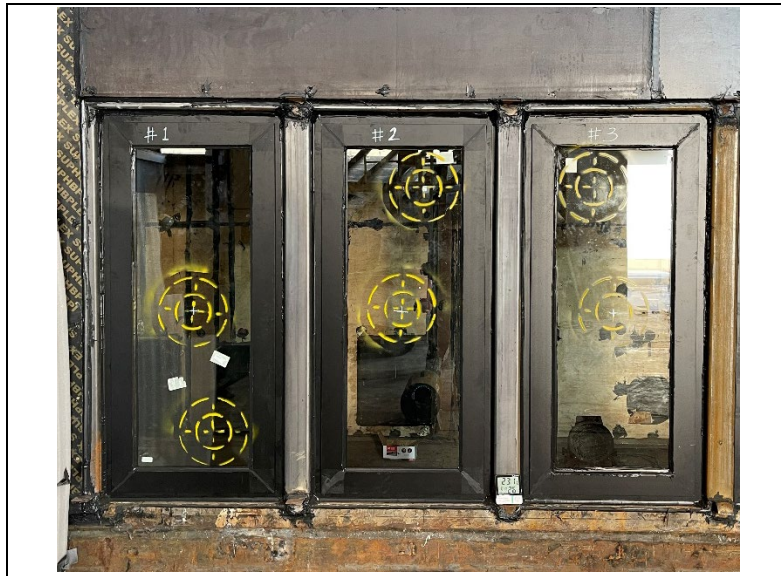
Photo No. 1

Specimens #1, #2 and #3 before impact test (Testing on December 20, 2021)

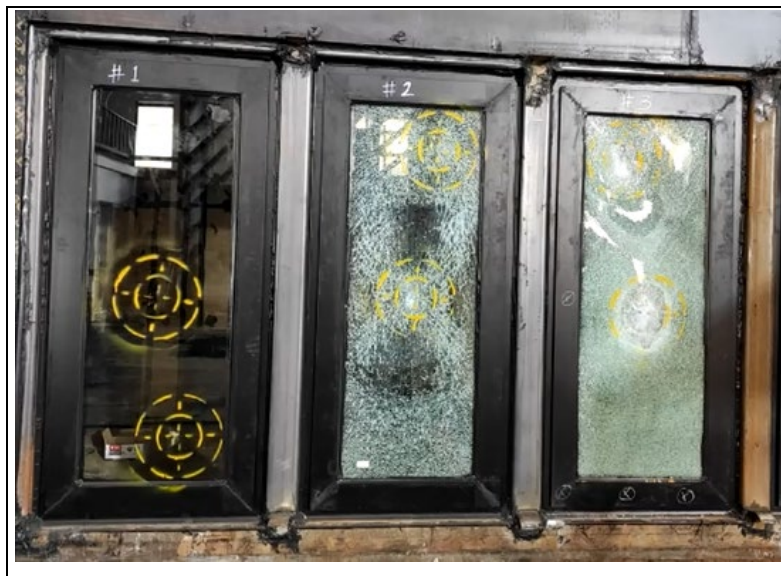
Photo No. 2

Specimens #1, #2 and #3 after impact test (Testing on December 20, 2021)

The large missiles impacted each intended target. Each impact location was carefully inspected. No signs of penetration, rupture, or opening after the large missile impact test were observed; as such, each test specimen satisfies the large missile requirements of TAS 201. Upon completion of testing, specimens tested for TAS 201-94 met the requirements of Section 1626 of the Florida Building Code, Building.

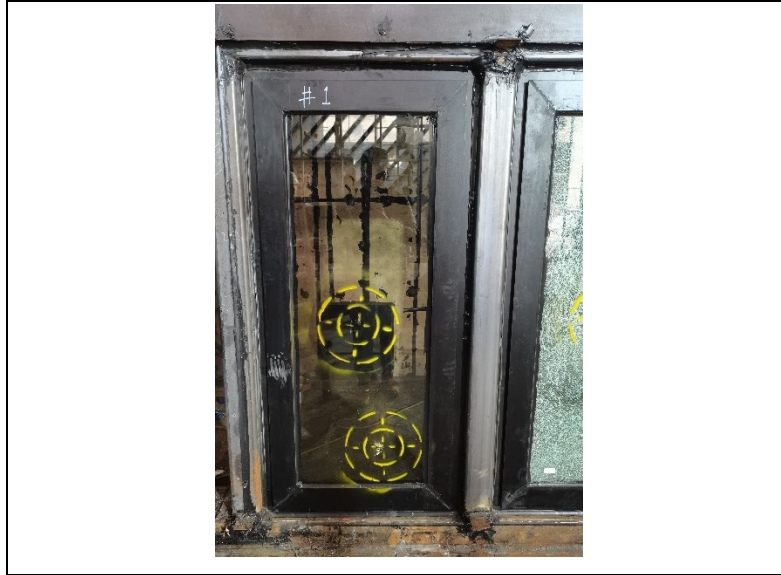
Photo No.3

Specimens #1 after cyclic test (Testing on December 21, 2021)

No signs of failure were observed in any area of the test specimens during the cyclic load test; as such, the test specimens satisfy the cyclic load requirements of TAS 203. Upon completion of testing, specimens tested for TAS 203-94 met the requirements of Section 1626 of the Florida Building Code, Building.

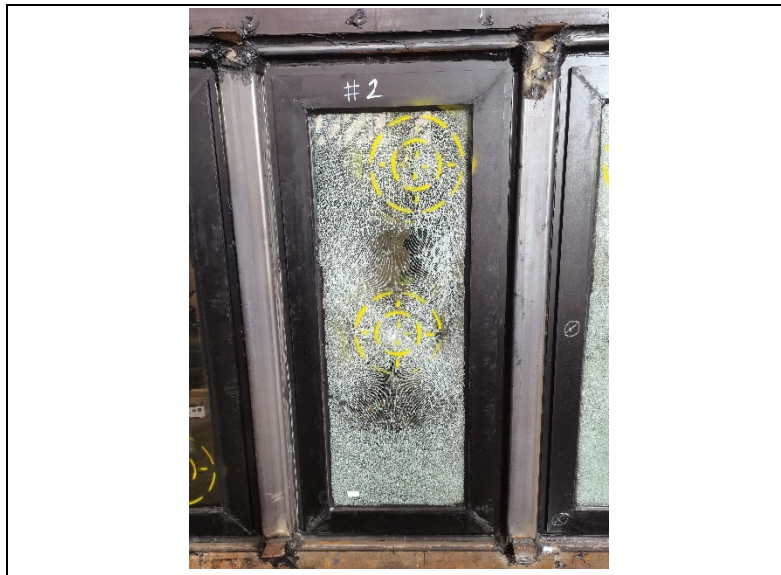
Photo No.4

Specimen #2 after cyclic test (Testing on December 21, 2021)

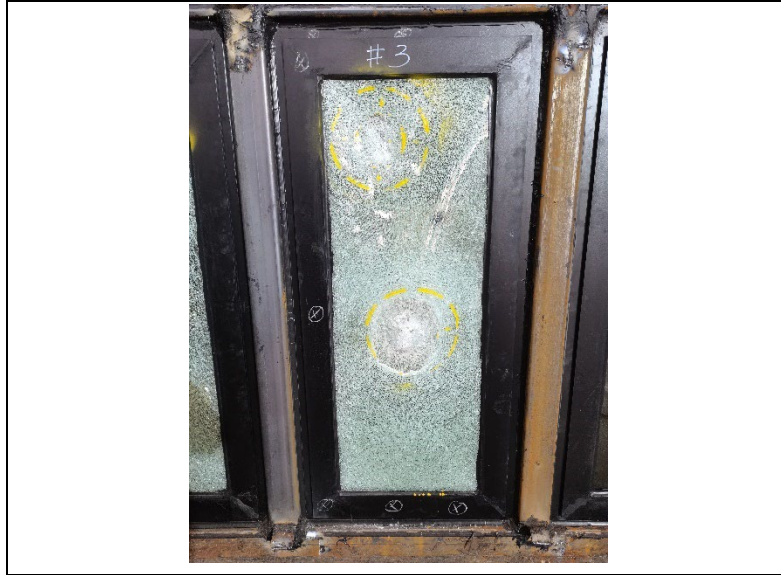
Photo No.5
Specimen #3 after cyclic test (Testing on December 21, 2021)

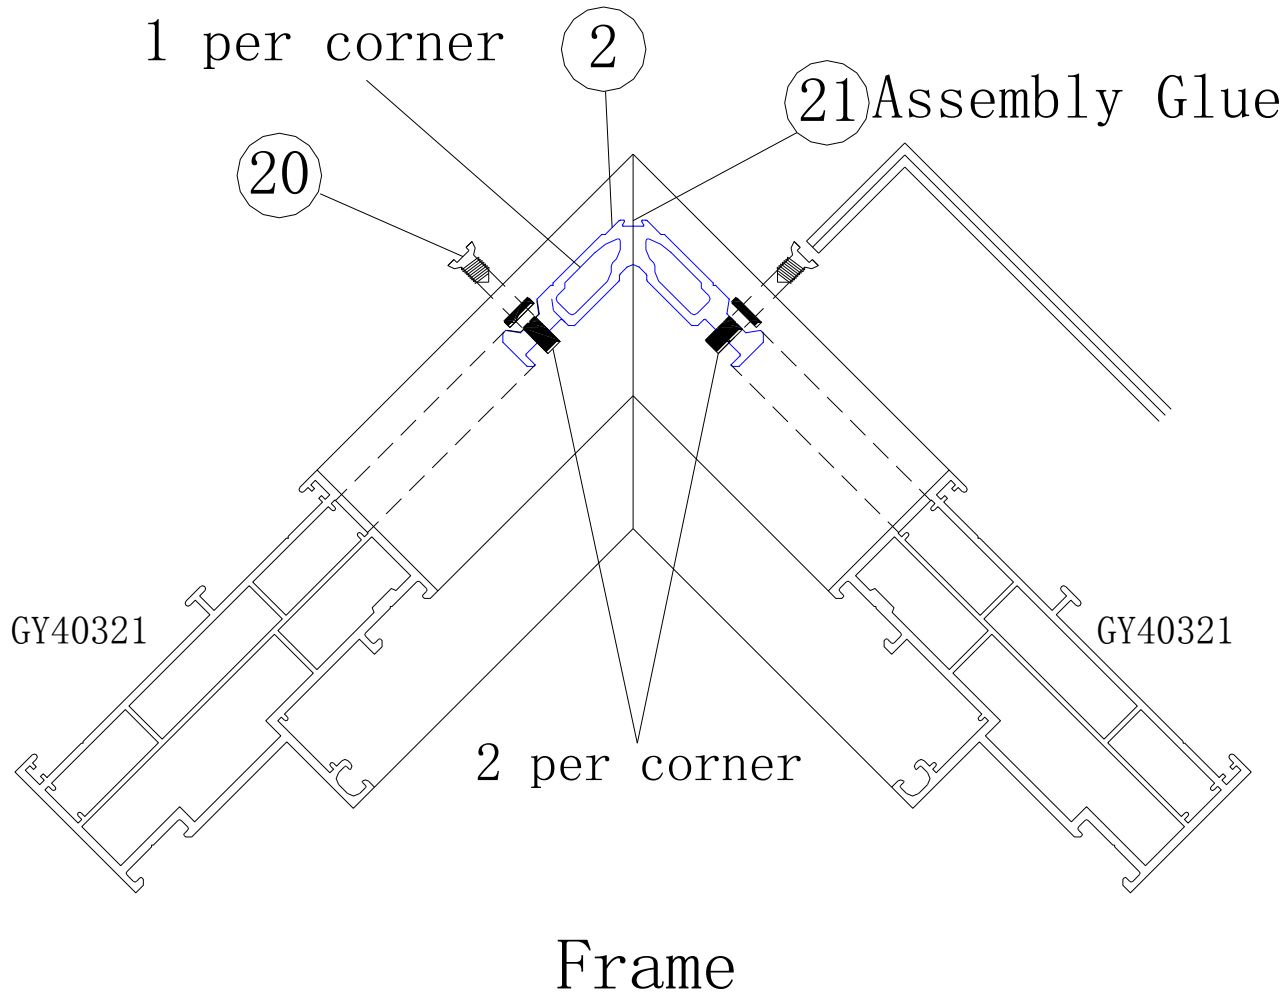
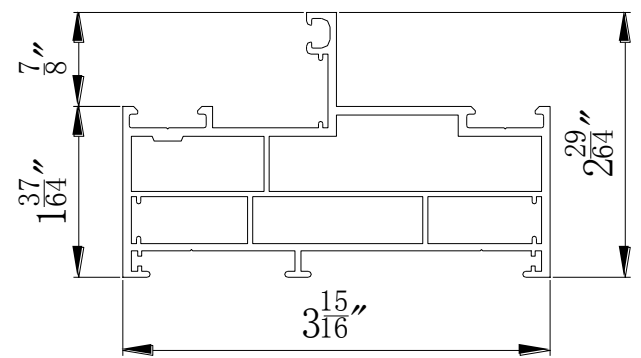
① WINDOW FRAME
GY40321

② CORNER BRACE
GY29748

FRAME MEMBER	MATERIAL	DESCRIPTION
Head, sill and jambs GY40321	6063-T5 Extruded Aluminum	3-15/16" Wide by 2-29/64" High 45° Mitre-Cut
	JOINERY TYPE	DETAIL
All frame Corners	Mechanically fastened	Frame members were in Mitre-cut with 45 degrees, butted and sealed with WEISS COSMOPUR 818C assembly glue, assembled with corner brace by 2 NLJP12 corner screws.

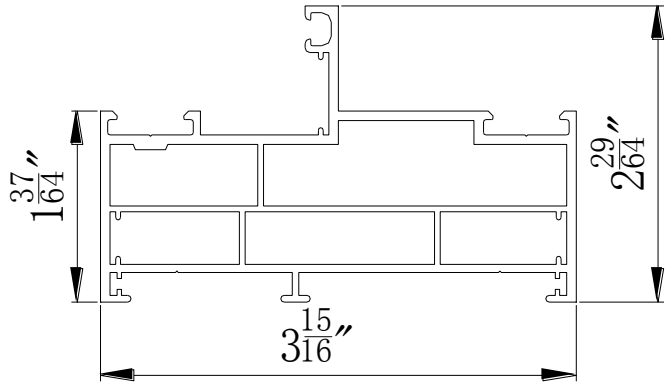
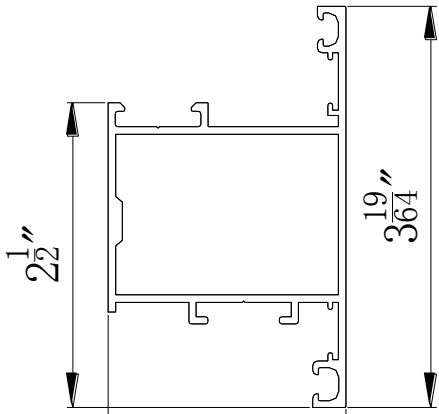
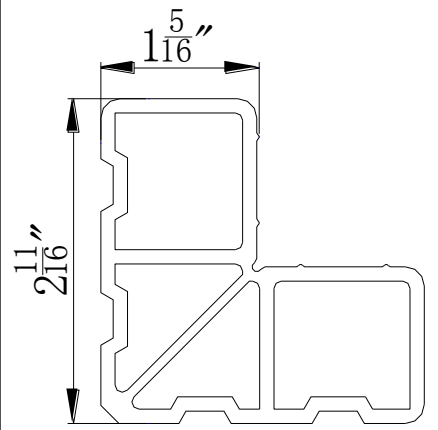
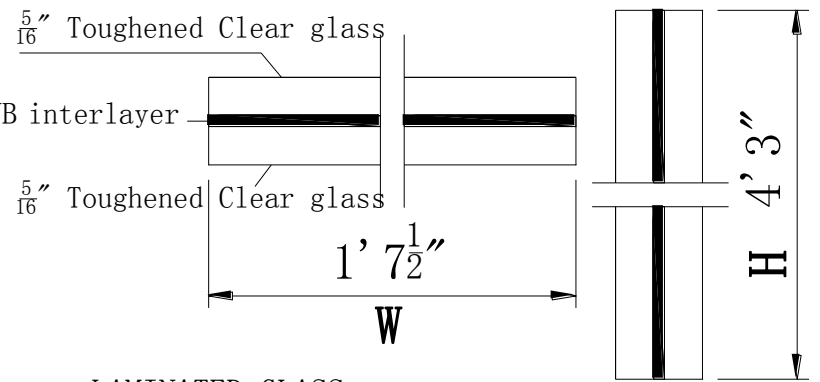
① WINDOW FRAME
GY40321

② CORNER BRACE
GY29748

③ SASH
GY40330

④ CORNER BRACE
GY29743

⑤ GLAZING BEAD
GY40325

⑥ EPDM GASKET
112.254

⑦ GLASS BLOCK
DP-948

⑧ LAMINATED GLASS
 $\frac{5}{16}'' + \frac{3}{32}'' \text{PVB interlayer} + \frac{5}{16}''$

SASH Member	PART #	MATERIAL	DESCRIPTION
Window Sash Head, sill & jambs	GY40330	6063-T5 Extruded Aluminum	1-31/32" Wide by 3-19/64" High, 45° Mitre-Cut
	Joinery Type	Detail	
All Corners	Mechanically fastened	Sash members were Mitre-Cut, butted and sealed with WEISS COSMOPUR 818C Assembly Glue, Assembly with Corner Bracket

GLASS TYPE	OVERALL THICKNESS	GLASS MAKEUP	GLAZING METHOD
Laminated Glass	23/32"	5/16" tempered glass 3/32" (PVB interlayer) 5/16" tempered glass	Glazed by assembling the frame members around the glass and sealed on the interior and exterior with 1/8" wide by 3/4" deep DOW CONING SJ168 silicon seal
