IMPORTANT PRODUCT INFORMATION

Product: IC693 CPU Modules

IC693CPU352-EK with Firmware Release 10.50

IC693CPU363-BE with Firmware Release 10.50

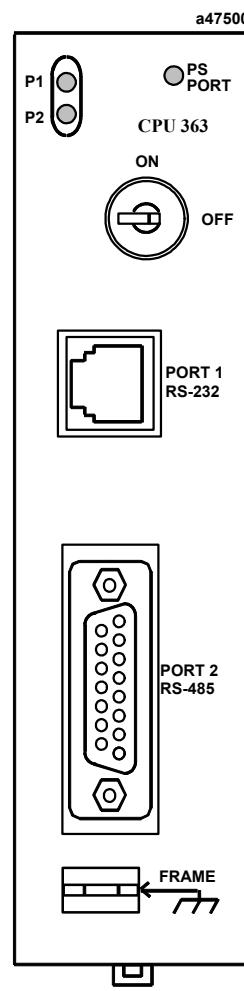
IC693CPU363 Data

CPU Type	Single slot CPU module
Total Baseplates per System	8 (CPU baseplate + 7 expansion and/or remote)
Load Required from Power Supply	890 milliamps from +5 VDC supply
Processor Speed	25 MegaHertz
Processor Type	80386EX
Typical Scan Rate	0.22 milliseconds per 1K of logic (Boolean contacts)
User Memory (total)	240K (245,760) Bytes. Note: Actual size of available user program memory depends on the amounts configured for the %R, %AI, and %AQ configurable word memory types (described below).
Discrete Input Points - %I	2,048
Discrete Output Points - %Q	2,048
Discrete Global Memory - %G	1,280 bits
Internal Coils - %M	4,096 bits
Output (Temporary) Coils - %T	256 bits
System Status References - %S	128 bits (%S, %SA, %SB, %SC - 32 bits each)
Register Memory - %R	Configurable in 128 word increments, from 128 to 16,384 words with DOS programmer, and from 128 to 32,640 words with Windows programmer 2.2 or later, VersaPro 1.0 or later, or Logic Developer-PLC.

Analog Inputs - %AI	Configurable in 128 word increments, from 128 to 8,192 words with DOS programmer, and from 128 to 32,640 words with Windows programmer 2.2 or later, VersaPro 1.0 or later, or Logic Developer-PLC.
Analog Outputs - %AQ	Configurable in 128 word increments, from 128 to 8,192 words with DOS programmer, and from 128 to 32,640 words with Windows programmer 2.2 or later, VersaPro 1.0 or later, or Logic Developer-PLC.
System Registers (for reference table viewing only; cannot be referenced in user logic program)	28 words (%SR)
Timers/Counters	>2,000 (depends on available user memory)
Shift Registers	Yes
Built-in Serial Ports	Three (one uses connector on PLC power supply). Supports SNP/SNPX slave (on all three ports) and RTU slave and Serial I/O (on Ports 1 and 2). Requires CMM module for CCM and PCM module for RTU master.
Communications	<i>LAN</i> – Supports multidrop. Also supports Ethernet, FIP, Profibus, GBC, GCM, and GCM+ option modules.

Override	Yes
Battery Backed Clock	Yes
Interrupt Support	Supports the periodic subroutine feature.
Type of Memory Storage	RAM and Flash
PCM/CCM Compatibility	Yes
Floating Point Math Support	Yes, firmware-based
