PFM Imp & Exp Co., Ltd.
Promising Flooring Material Limited

CALACATTA MARBLE FLOORING REPAIRING PROCESS

DIAMOND TWIN TOWER

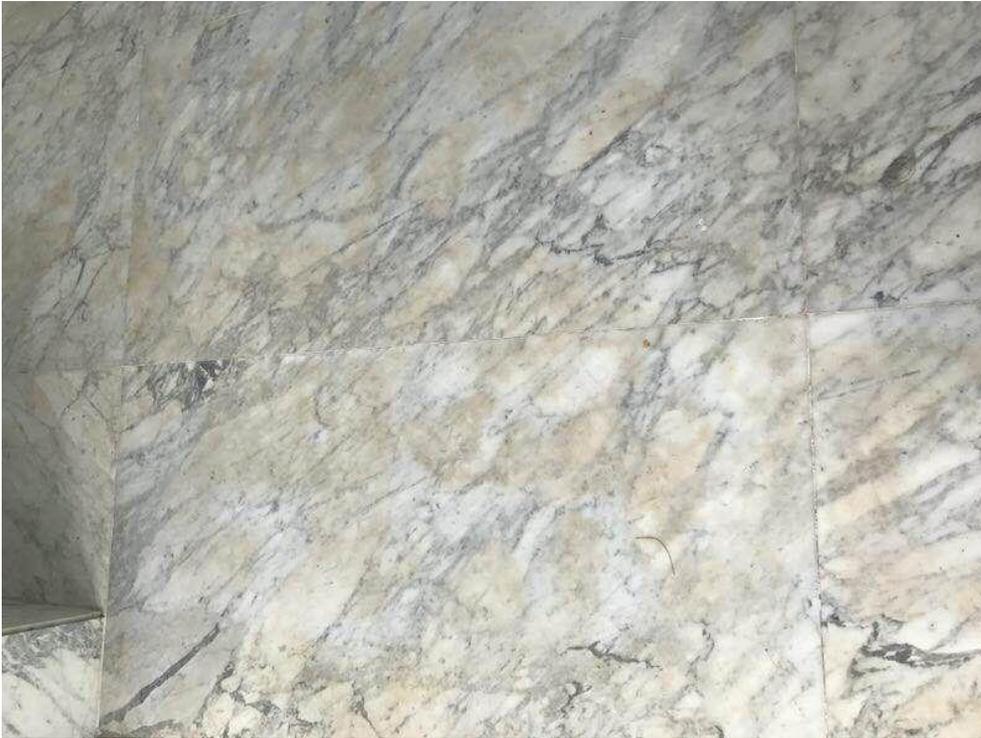
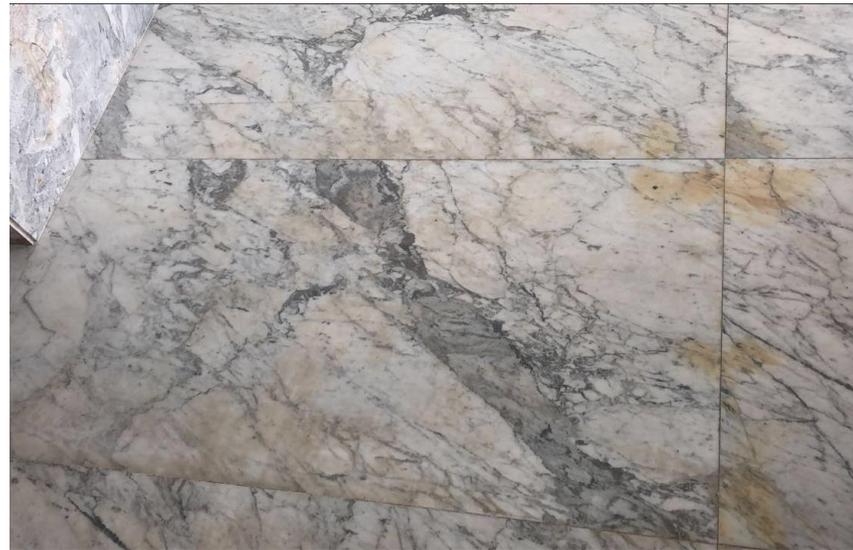
Our company has taken the contract of the most stone floors and wall cladding in this project, but for lobby area, the client bought directly from Italy, the calacatta. However because of wrong installation, they have caused a huge trouble, after two weeks, the yellow stains started to come from inside of bottom. Like the below pictures.

They have used black cement to install the white stone without any protection due to lack of experiences of applying marble.

To help our client to get out this situation to meet the grand opening date, we sent one technician from our team and started to save the marble floors.

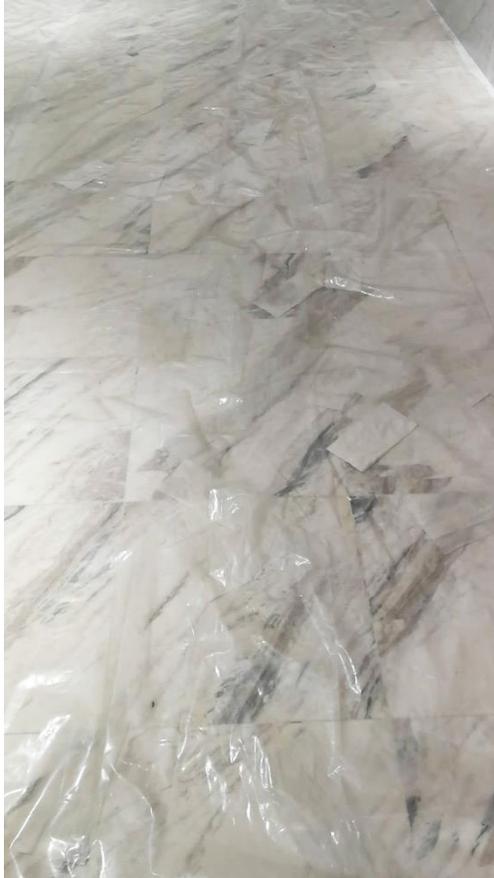
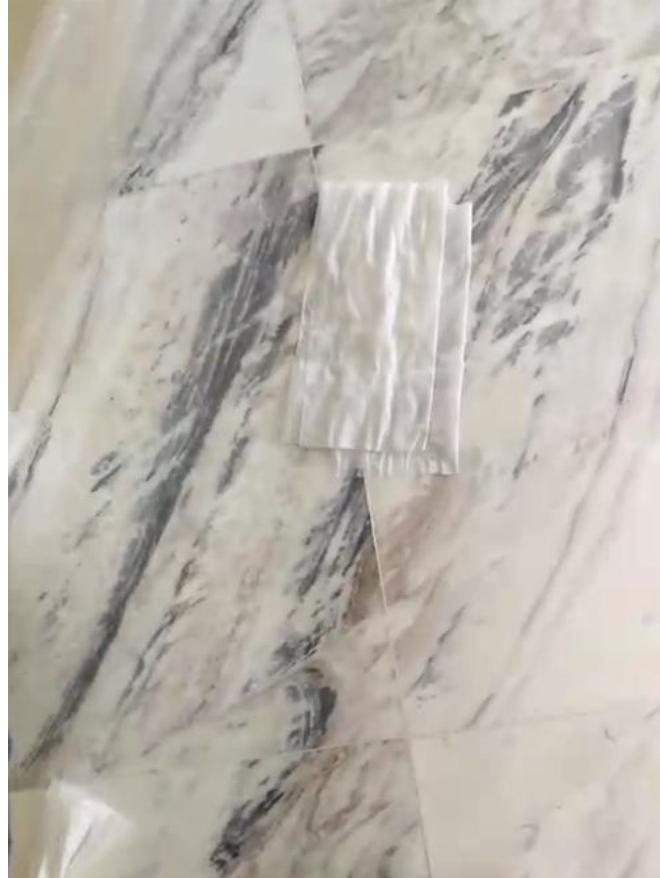
Step 3: Cover The Surface With Tissue Paper, And Seal It With Plastic Film, Keep It For 5-8 Hours

Cover The Surface With Tissue Paper

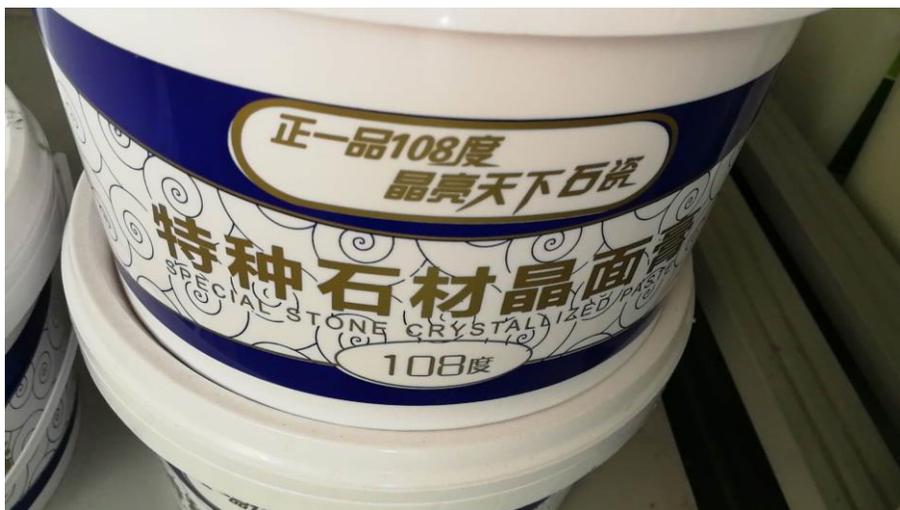
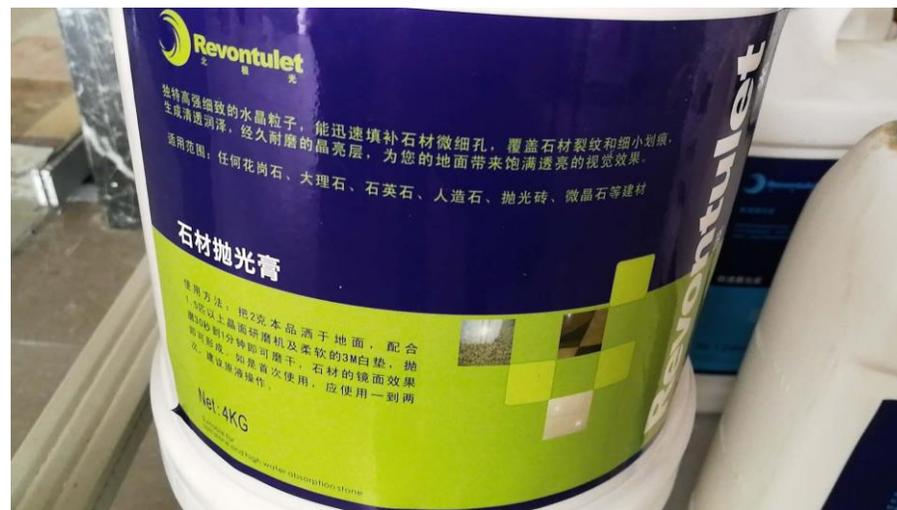
Step 5: Polish The Floor Again

the polishing material we use is as below:
