REPORT NUMBER: 150327002SHF-BP-3
ORIGINAL ISSUE DATE: August 28, 2015

UPVC Sliding Window
Model: RP002

TEST REPORT

Report of Testing an UPVC Sliding Window (Model: RP002) for compliance with the applicable requirements of the following criteria: AS 2047-2014 “Windows and external glazed doors in buildings”, AS 4420.2-1996 “Windows –Methods of test, Method 2: Deflection test”, AS 4420.3-1996 “Windows –Methods of test, Method 3: Operating force test”, AS 4420.4-1996 “Windows –Methods of test, Method 4: Air infiltration test”, AS 4420.5-1996 “Windows –Methods of test, Method 5: Water penetration resistance test”, AS 4420.6-1996 “Windows –Methods of test, Method 6: Ultimate strength test”.

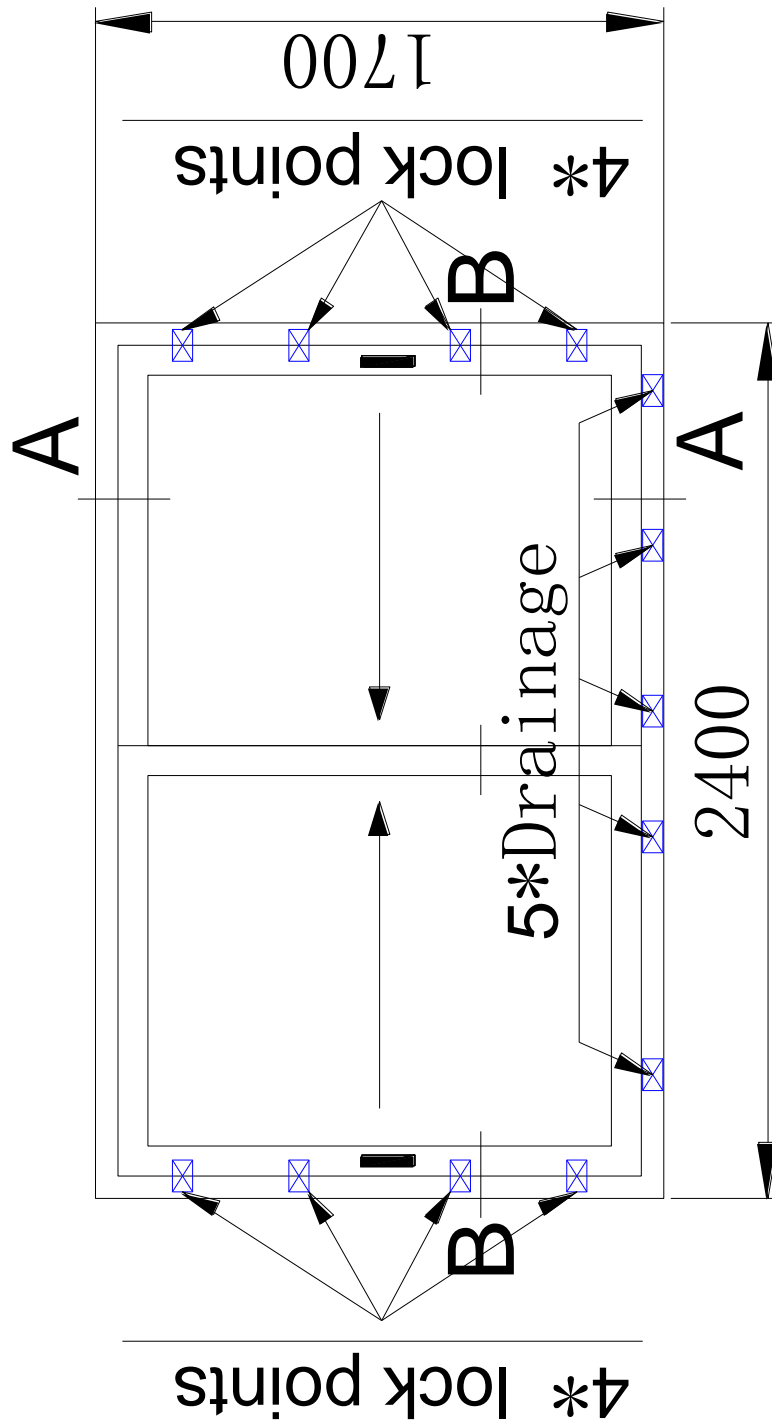
Fig.1 Drawing of Representative Sample

Product Name	UPVC Sliding Window
Model	RP002
Dimension of Window Frame	2400 x 1700 mm
Dimension of Window Sash	1192 x 1614 mm
UPVC Profile	Model: SL58 Manufacturer: VEKA Plastics (Shanghai) Co. Ltd.
Glazing	Dimension: 1085 x 1506 mm Structure: 5 mm Clear, Low E + 12 A + 5mm Clear, Toughened Supplier: Xinfuxing Glass Co., Ltd
Hardware	Model: EQ9 Supplier: Roto Frank AG
Drainage	Dimension: 5 x 30 mm Quantity: 5 PCS
Gasket (between sash and frame)	Material: EPDM, Code-112.300/112.751 Supplier: Jiangyin Haida Rubber and Plastic Co., Ltd
Pile Strip (between sash and frame)	Material: Silicone Pile Strips Supplier: Haining Lijialong Pile Weather Strip Co., Ltd.
Sealant of Glass	Material: Neutral Silicone Sealant Supplier: Hangzhou Zhijiang Silicone Co., Ltd

The sample ID number was S150327002SHF-003. The drawings of the representative sample were referenced in Appendix A.

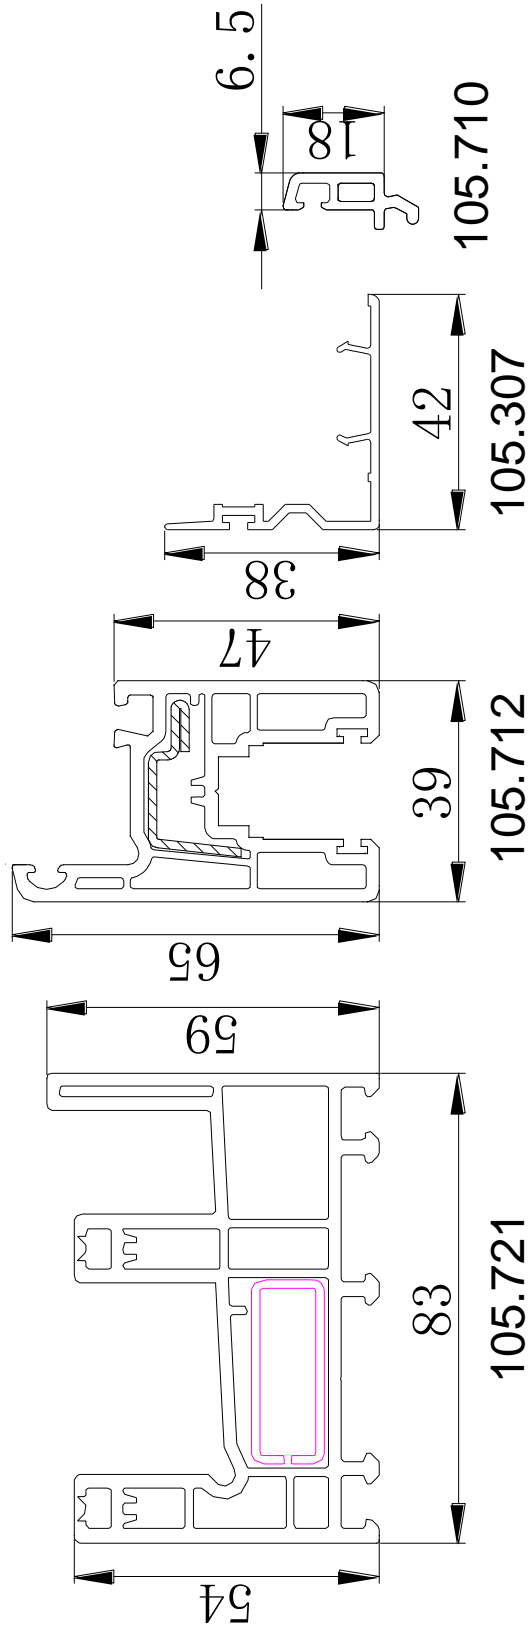
Fig.2 Sectional View of the Profiles

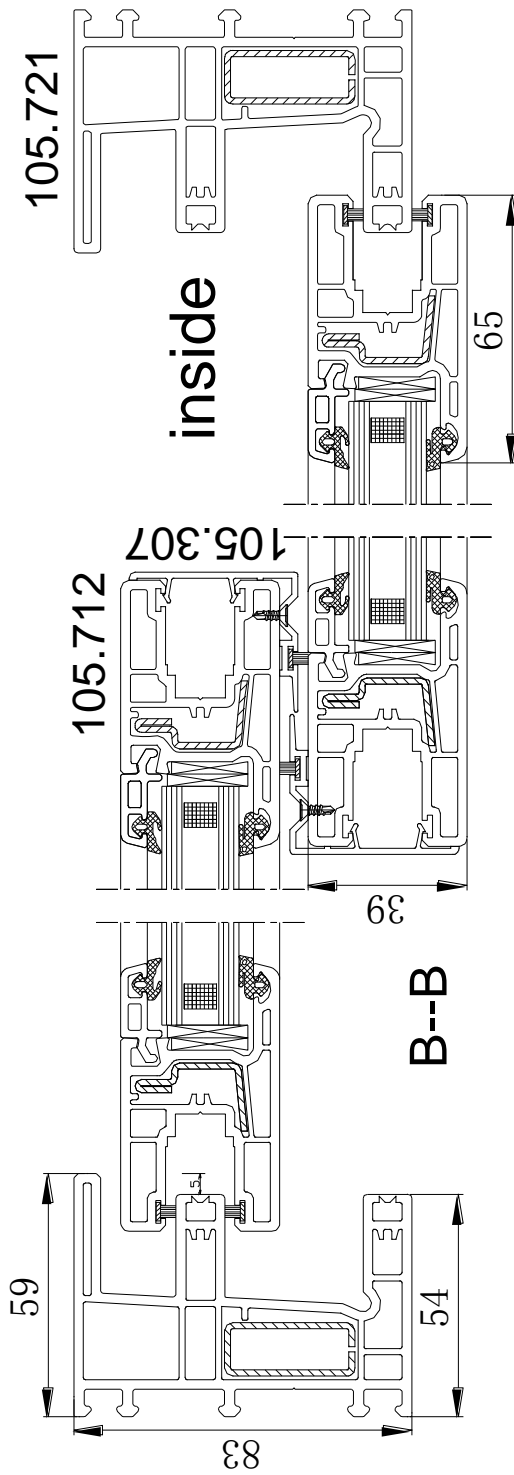
Fig.3 Sectional View of the Profiles

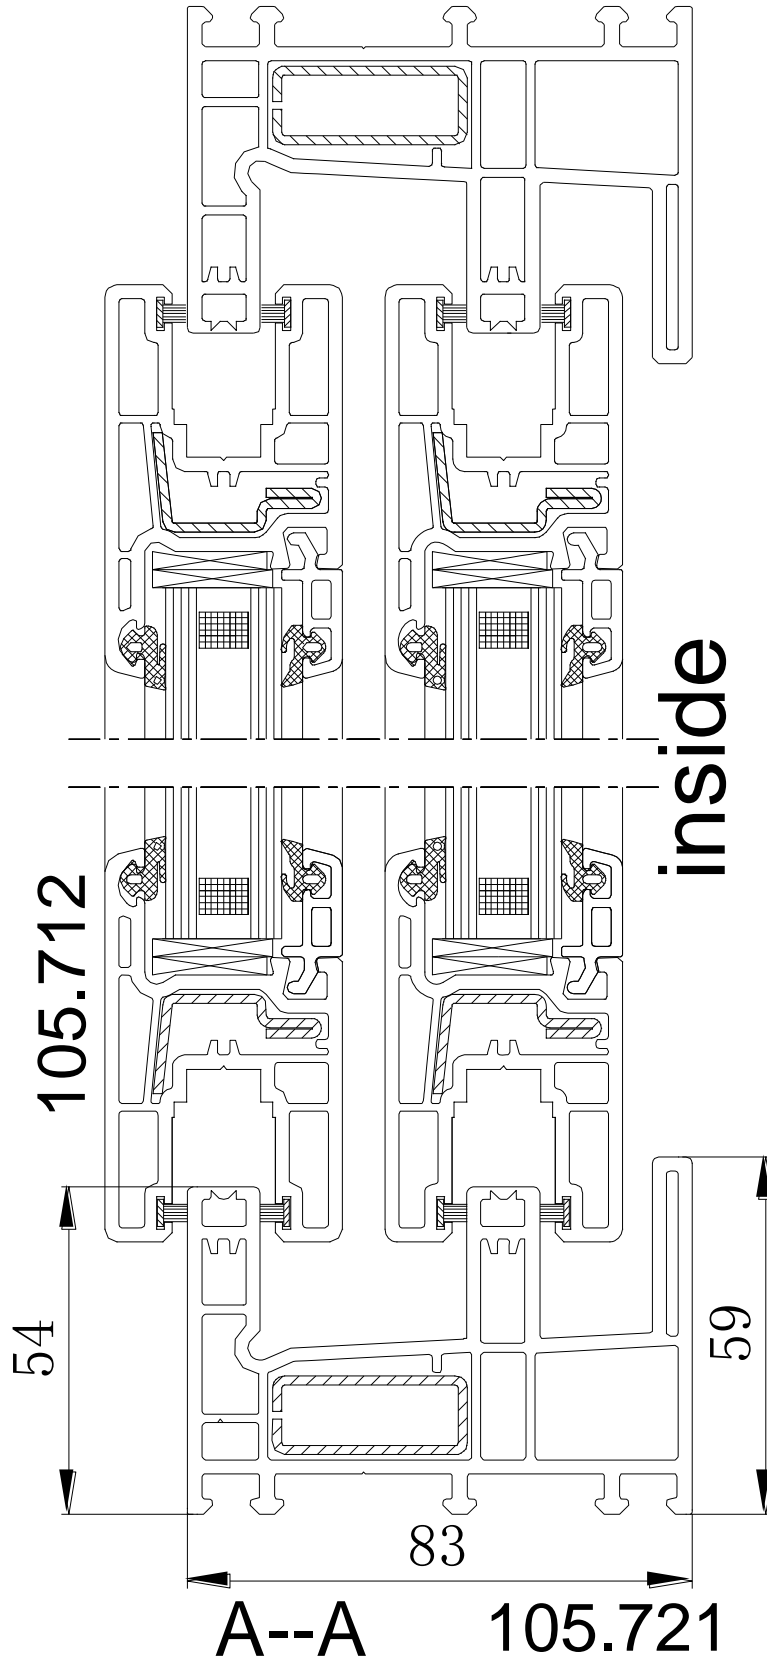
Fig.4 Sectional View of the Profiles

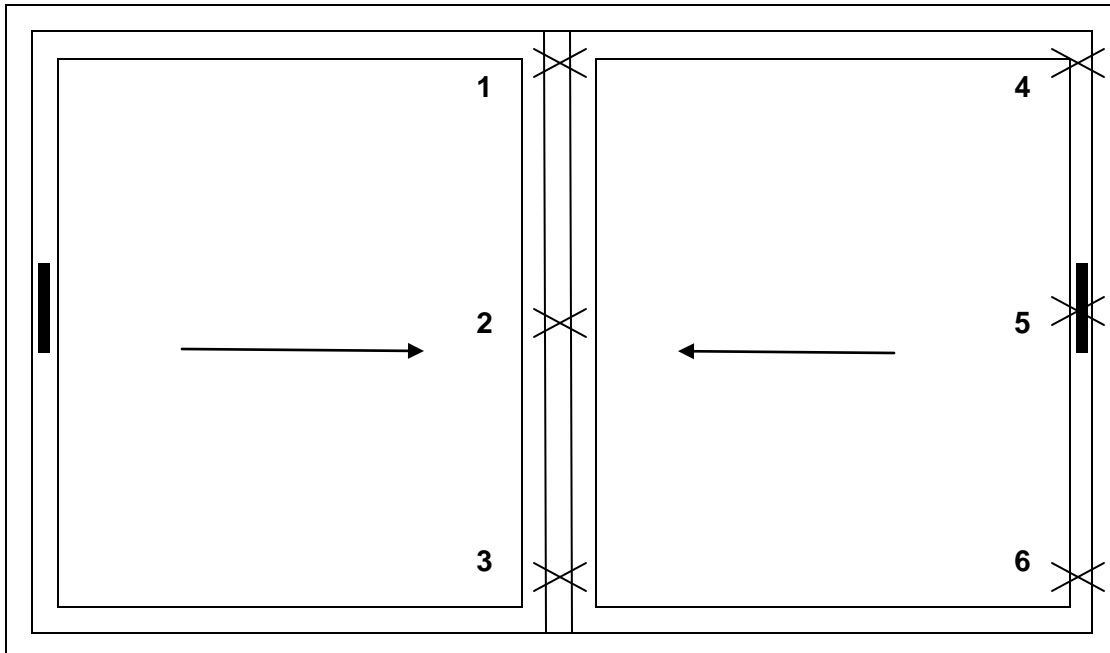
Outside View

- Span length, $L = 1590 \text{ mm}$
- Maximum allowable deflection (Mullion) = $\text{Span} / 250 = 6.4 \text{ mm}$
- Span length, $L = 1590 \text{ mm}$
- Maximum allowable deflection (Sash) = $\text{Span} / 250 = 6.4 \text{ mm}$
- Test Pressure (Serviceability design wind pressure), $P = 1800 \text{ Pa}$, Rating N6 (General).

Fig.5 Locations of Displacement Measuring Devices

Member (mm)		Test Pressure (Pa)	Deflection (mm)			Actual Deflection	Maximum allowable Deflection /Span Ratio	Verdict
Item	Span Length		1	2	3			
Mullion	1590	+P/4 = 450	1.4	1.8	1.4	1.9	6.4	Pass
		+2P/4 = 900	2.6	3.2	2.3			
		+3P/4 =1350	3.5	4.7	3.0			
		+P = 1800	4.5	6.0	3.7			
		0	0.5	0.7	0.8			
Mullion	1590	-P/4 = -450	1.6	2.2	1.6	2.0	6.4	Pass
		-2P/4 = -900	2.9	3.8	2.8			
		-3P/4 = -1350	4.4	5.8	4.1			
		-P = -1800	6.1	7.8	5.6			
		0	0.9	1.3	1.1

Member (mm)		Test Pressure (Pa)	Deflection (mm)			Actual Deflection	Maximum allowable Deflection /Span Ratio	Verdict
Item	Span Length		4	5	6			
Sash	1590	+P/4 = 450	0.4	1.0	0.0	3.6	6.4	Pass
		+2P/4 = 900	0.8	2.1	0.1			
		+3P/4 =1350	1.1	3.3	0.3			
		+P = 1800	1.4	4.5	0.5			
		0	0.2	0.2	0.2			
Sash	1590	-P/4 = -450	0.4	1.4	0.1	3.8	6.4	Pass
		-2P/4 = -900	0.6	2.7	0.1			
		-3P/4 = -1350	0.9	3.8	0.5			
		-P = -1800	1.2	4.8	0.9			
		0	0.4	0.6	0.5
